# VEHICLE INSPECTION REPORT

**LX17CTU**

## Mercedes-Benz Sprinter 514 CDI

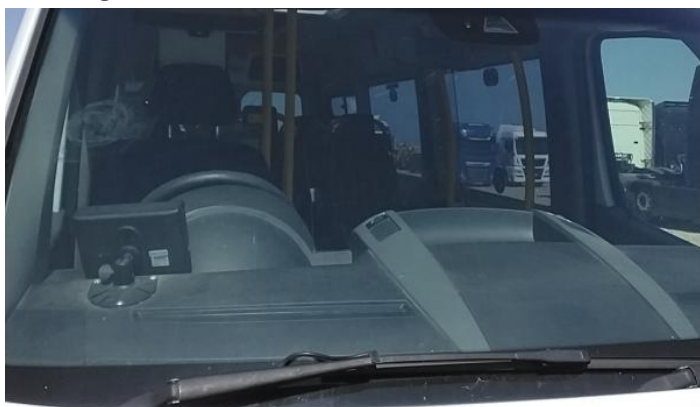
1: Screen Front  
Chipped  
Over 10mm

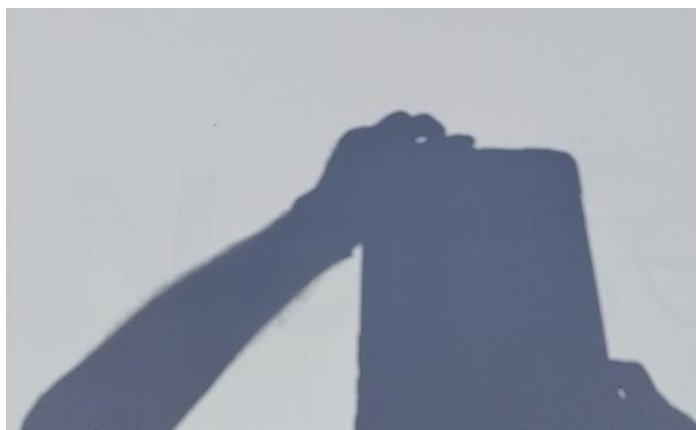
2: Bonnet  
Chipped  
Multiple Chips

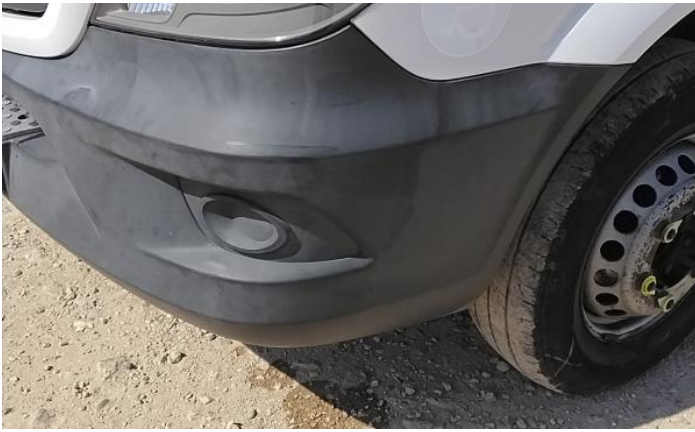
3: Bumper Front Moulding  
Scuffed (Unpainted)  
UpTo 100mm

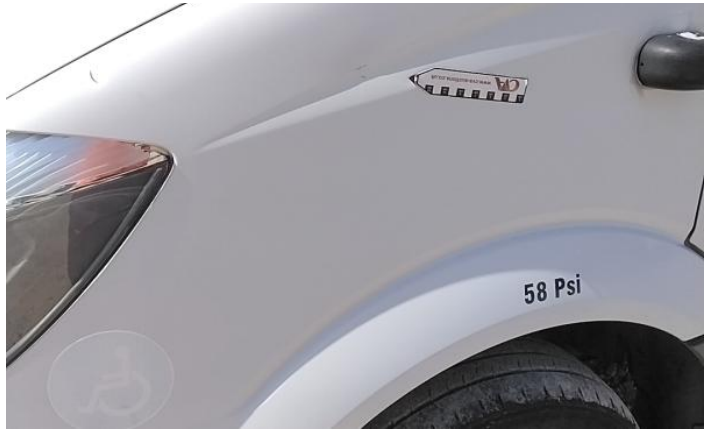
4: Wing nsf  
Dented  
With Paint Damage

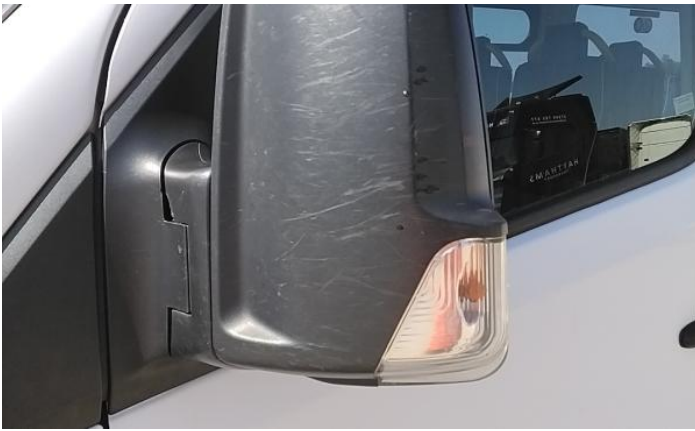
5: Door Mirror Assy nsf  
Scuffed (Unpainted)  
Over 100mm

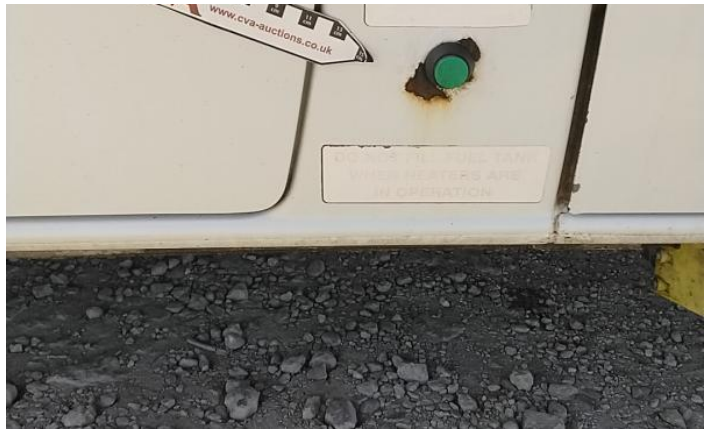
6: B Post ns  
Rusted  
Over 5mm

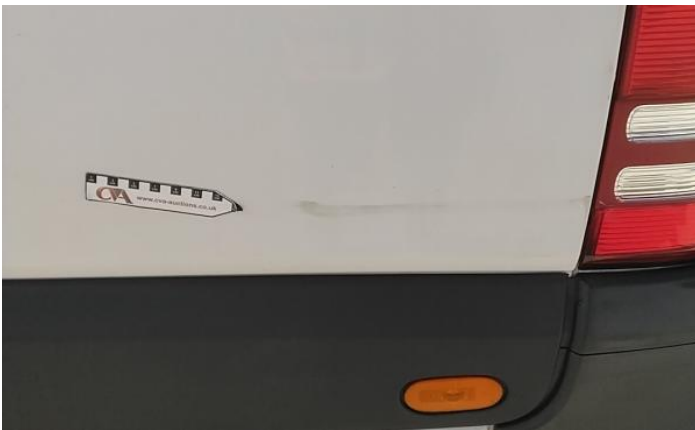
7: Qtr Panel nsr  
Scratched  
Over 25mm Not Thru Paint

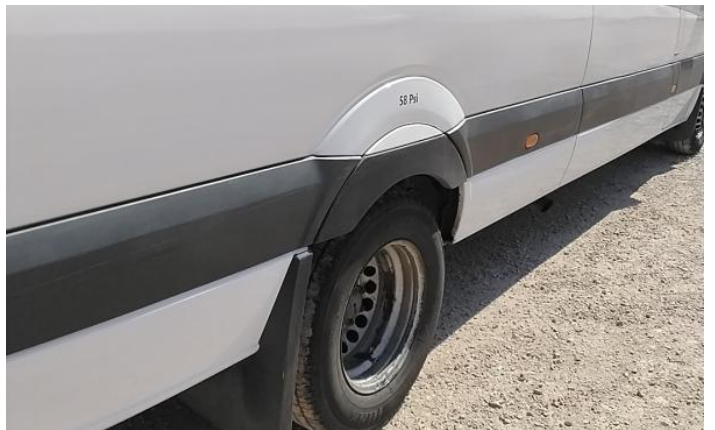
8: Qtr Panel Moulding os  
Scuffed (Unpainted)  
Over 100mm

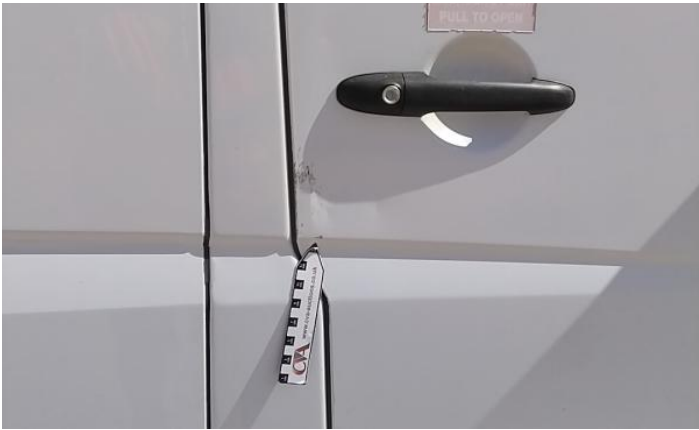
9: Door osf  
Dented  
With Paint Damage

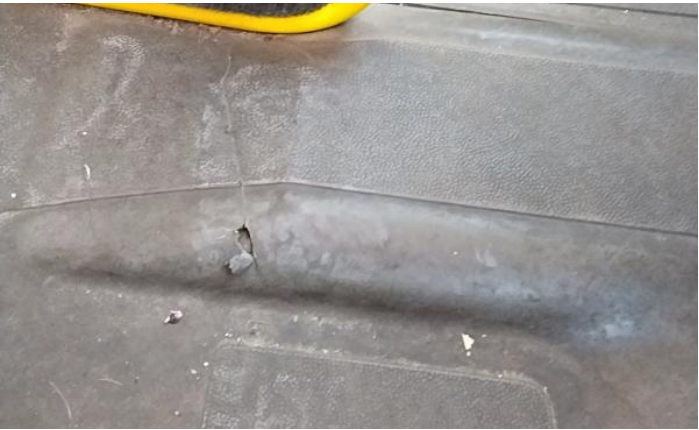
10: Carpets Front  
Holed  
Over 3mm
