# VEHICLE INSPECTION REPORT

**LX17CTU**

## Mercedes-Benz Sprinter 514 CDI

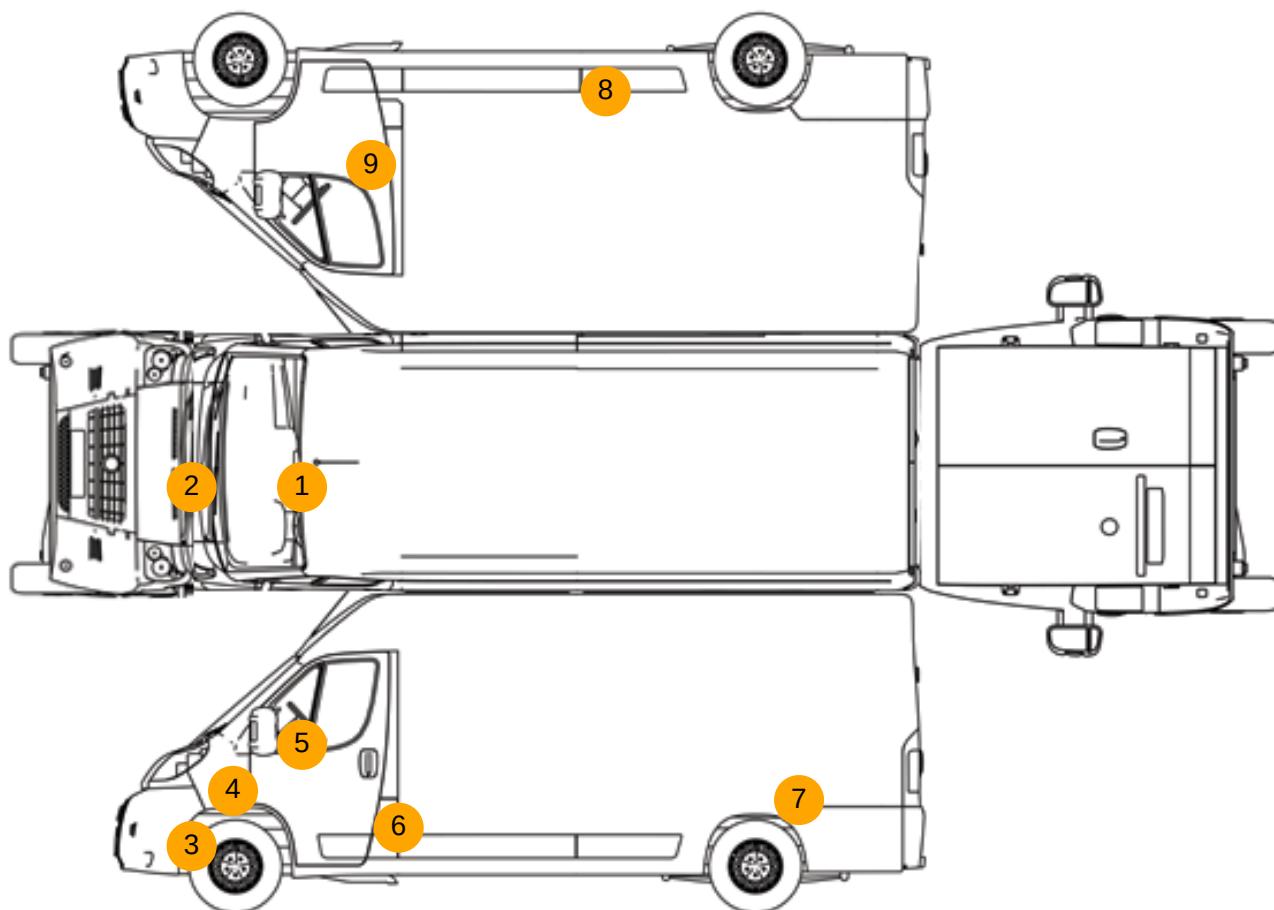
## Condition Check

4: Wing nsf  
Dented  
With Paint Damage

6: B Post ns  
Rusted  
Over 5mm

9: Door osf  
Dented  
With Paint Damage
